## Composites: Part A

## Damage resistance and tolerance of carbon/epoxy composite coupons subjected to simulated lightning strike

Paolo Feraboli\*, Mark Miller

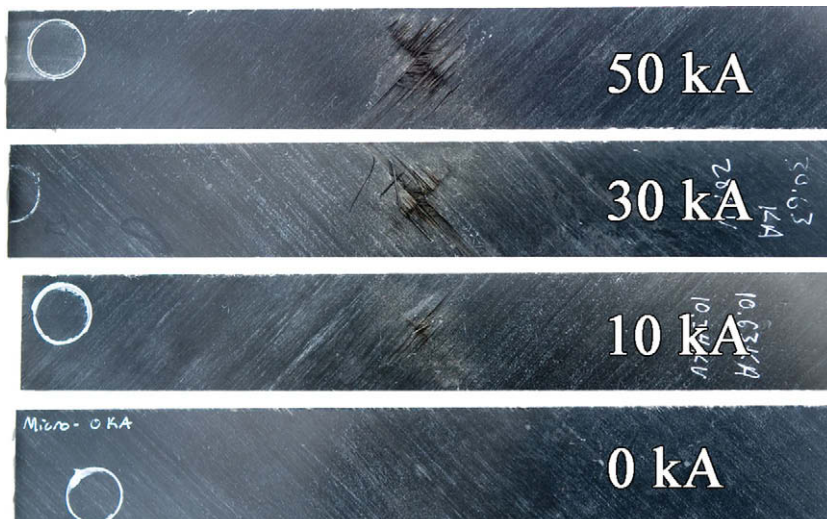
Both unnotched (or pristine) and filled-hole specimens are tested. Unnotched specimens exhibit increasing external damage for increasing current intensity, Fig. 8. Damage manifests as visible fiber fracture in the outer ply oriented at 45°, as well as

Fig. 8. Typical unnotched specimens, from pristine at the bottom to maximum current at the top.

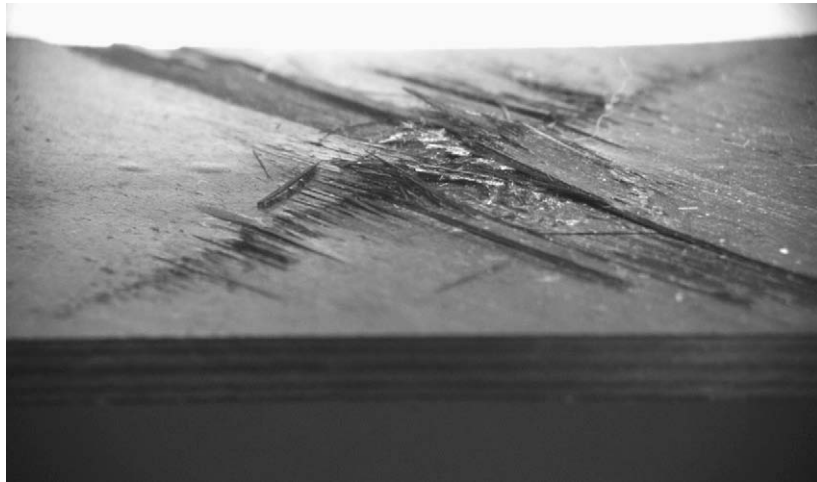
longitudinal splitting and bulging of the area around the strike, Fig. 9. In some cases the upper ply or plies even separate in small chips or fragments and leave an empty space on the surface. In general however, the damage appears to be confined to the surface of the specimen and in the region immediately surrounding the strike zone. For the given specimen, boundary conditions and loading configuration, damage does not reach the backface of the specimen. The visible damage area appears to be almost identical

Fig. 9. Close-up of surface damage for unnotched specimens at 50 kA.

between the 30 and the 50 kA strikes, but caution should be exercised in interpreting these results. The finite width of the specimen imposes limitations on the propagation of damage, and hence these results cannot be extrapolated to larger panels, which will be the focus of future research.

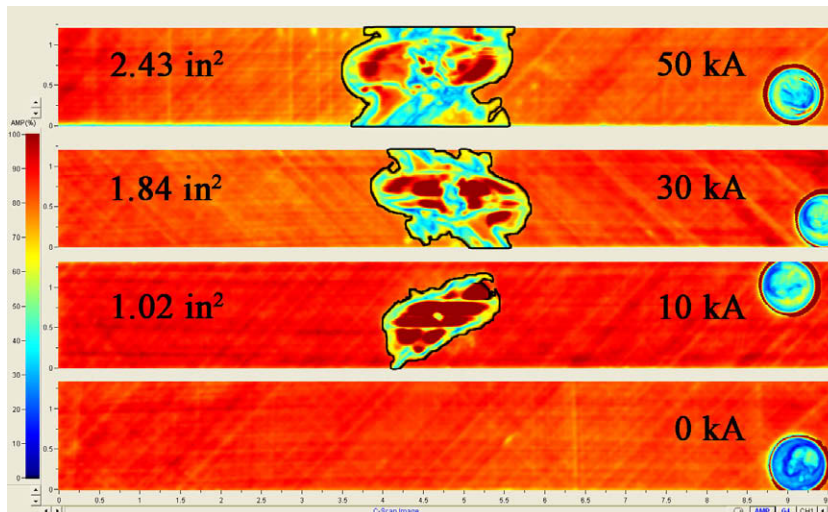
Ultrasonic images for a representative unnotched specimen for each of the strike levels are reported in Fig. 10. The circular object appearing on the side of each specimen is a dime (USD 0.10) that is used for reference during the ultrasonic scan. Fig. 10 shows the shape of the damage area, which tends to be elongated in the direction of the fibers in the outer ply, and reports a calculated damage area. Although there appear to be a clear trend of increasing projected damage area for increasing current intensity, the size of the damage areas for the 30 and 50 kA strikes are relatively similar. Beyond 10 kA, the damage area reaches the boundaries of the specimen and is then forced to grow longitudinally. However, with these finite-width limitations in mind, it is possible to perform quantitative comparisons between specimens, and obtain the plot in Fig. 11. For the unnotched specimen it appears that the projected damage area increases linearly up to 30 kA, and then levels off, for the reasons mentioned before. From the plot it can be seen

Fig. 10. Projected damage area obtained via C-scan for unnotched specimens.

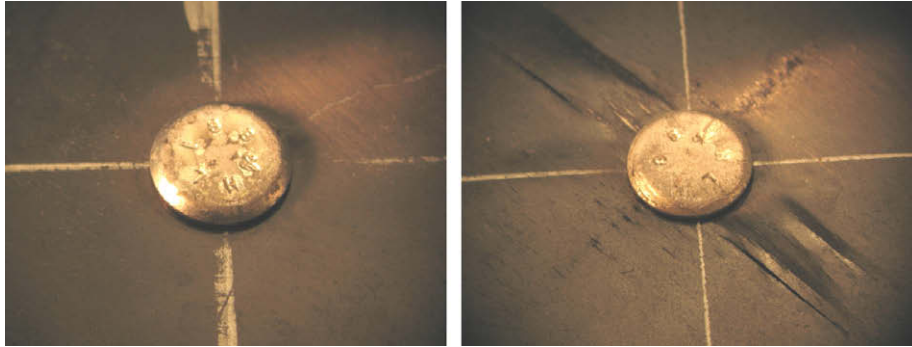
For filled-hole specimens the results are dramatically different. For 10 kA strikes, the only damage visible is surface pitting of the fasteners on the head side, where the strike takes place, Fig. 12. However, for the 30 and 50 kA strike the surface damage is much

more extensive than in the unnotched specimens, Figs. 12–14. Besides pitting of the fastener, severe bulging of the plies toward the surface is visible in the proximity of the fastener, and extensive fiber breakage observable on both top and back faces. Entire laminate segments delaminate throughout the thickness of the specimen, and in some cases even split and detach from the bulk of the specimen itself. At 50 kA, the fastener appears to sink inside

Fig. 12. Close-up of top surface fastener and laminate damage for filled-hole specimen at 10 and 30 kA.

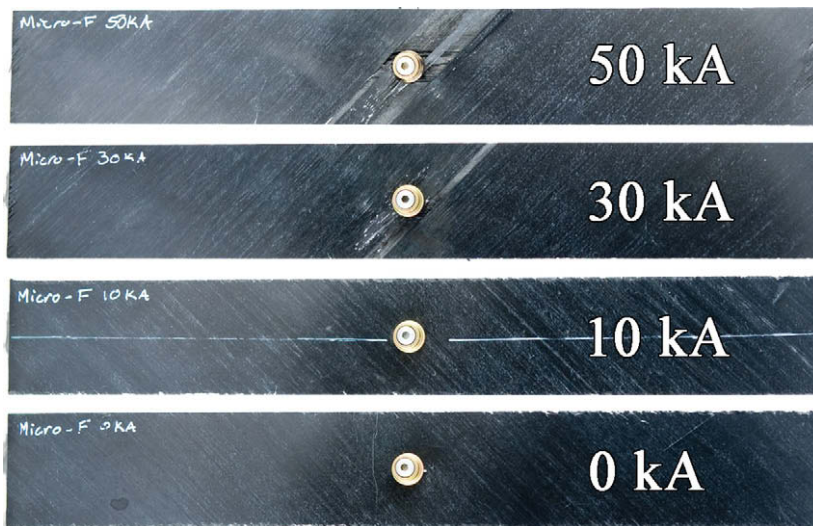
Fig. 13. Typical filled-hole specimens, from pristine at the bottom to maximum current at the top.

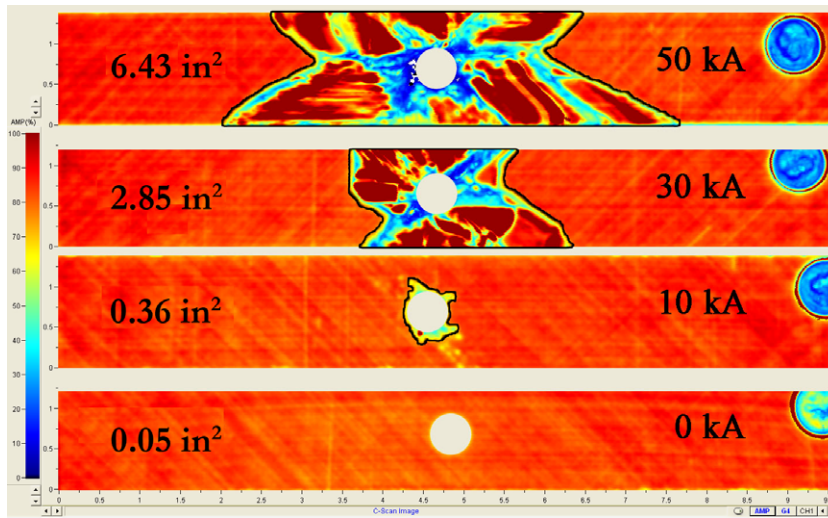
Fig. 15. Projected damage area obtained via C-scan for filled-hole specimens.

Ultrasonic images for a representative filled-hole specimen for each of the strike levels are reported in Fig. 15. In the pristine specimen the fastener appears as a white round, with an area of 0.05 in<sup>2</sup> (32.2 mm<sup>2</sup>) approximately. Fig. 15 confirms that for the 10 kA strike the damage area is contained in the fastener itself, or in the immediate proximity of the fastener hole. For 30 and 50 kA strikes, however, there appears to be a radical increase in damage area, and at 50 kA the vast majority of specimen appears to be damaged. From the ultrasonic image it is only possible to obtain information about a projected damage area; hence, to further identify the location and nature of the damage it is necessary to inspect the cross-section via micrography, as discussed later in the paper. Once again it is important to remember that the energy used to inflict damage exceeds the amount that the specimen can contain within its short width, and hence the damage is forced to grow longitudinally.

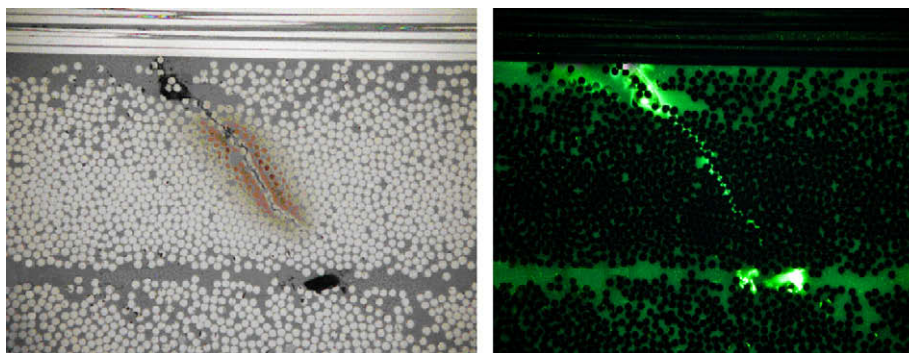
Fig. 22. High magnification micrograph of localized area of pyrolyzed fibers and vaporized matrix in specimen after 50 kA strike under brightfield (left) and UV light with dye penetrant (right).

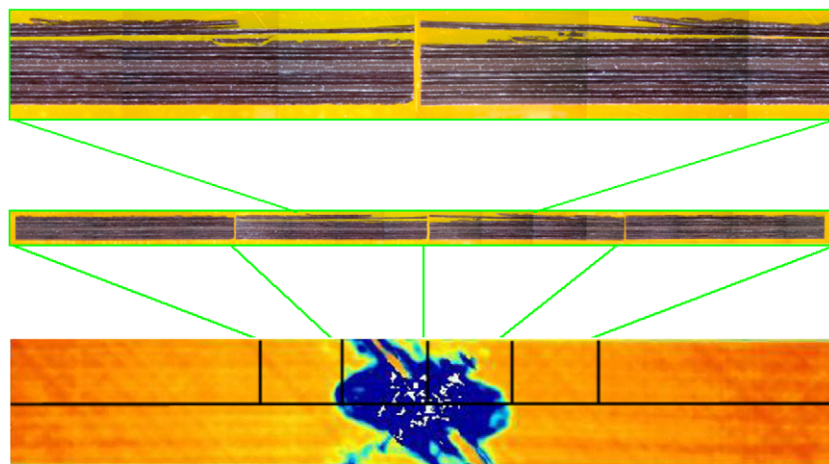
For 30 kA unnotched specimens, Fig. 24, the top +45° surface ply is completely obliterated and separated from the laminate, the adjacent 2nd and 3rd 0° plies remain intact but burst open toward the outside, and the 4th –45° ply appears to be also completely obliterated. A major delamination appears to run along the interface between the 4th and the 5th ply, which is the first of a three 0° stack. The remaining part of the specimen appears intact.

Fig. 24. C-scan and relative micrograph of 30 kA strike unnotched specimen.

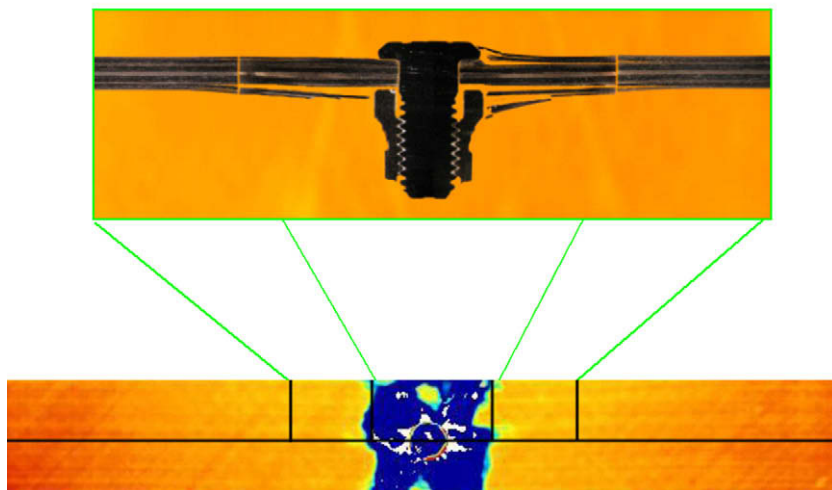
Fig. 28. C-scan and relative micrograph of 50 kA strike filled-hole specimen.

Fifty kiloamperes filled-hole specimens, Fig. 28, show even more extensive damage, with both top and bottom plies splaying outward, and extensive delamination fronts at all interfaces between high and low conductivity plies. Integrity of the specimen is completely compromised.
