## Composites: Part A

## Damage resistance and tolerance of carbon/epoxy composite coupons subjected to simulated lightning strike

Paolo Feraboli\*, Mark Miller

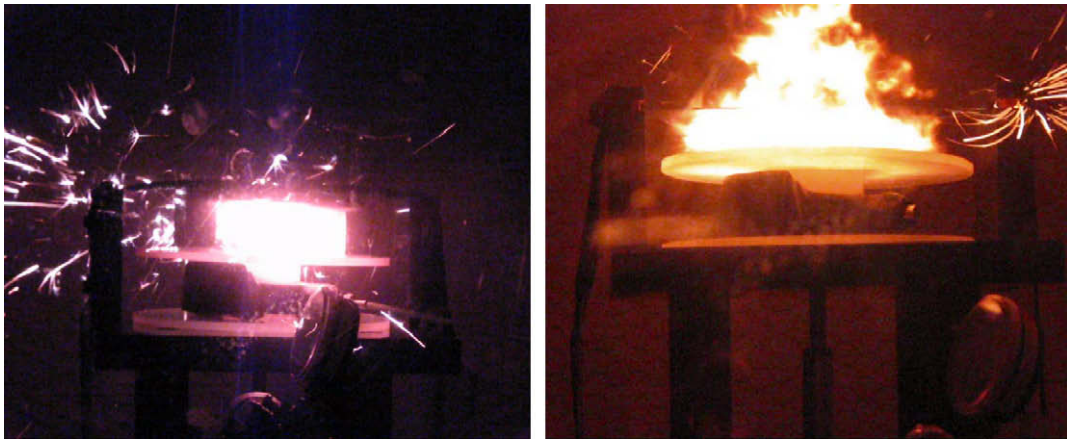
The strikes produce a loud sound, similar to that of a detonation, and generate a short, bright light, followed by a cloud of fire and sparks, likely due to the incandescent blast wave charged with carbon fiber and epoxy particles. Fig. 6 is extracted from a digital video recording at the time of peak current during the strike. However, if a digital camera with an exposure time longer than the

Fig. 6. Still image extracted at peak intensity from a video recording of a 50 kA strike.

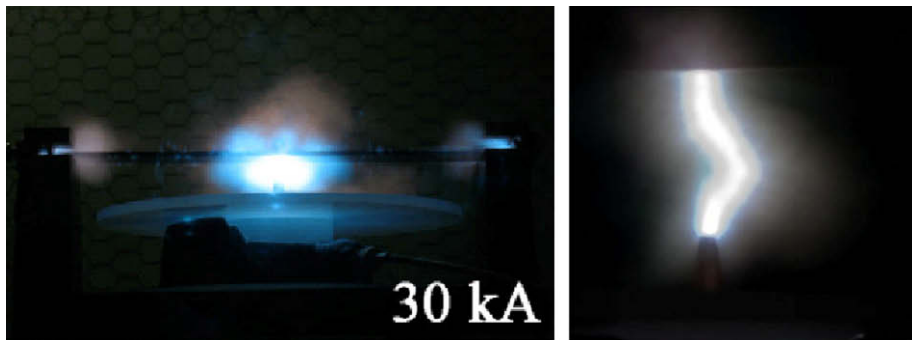
duration of the strike itself, and a series of polarized filters that reduce the intensity of the lighting are employed, it is possible to actually reduce the amount of “noise” in the image and focus on the central portion of the electrical channel, Figs. 6 and 7.

Fig. 7. Details of the strikes at 30 kA, obtained using a digital camera with a long exposure time and a system of polarized lenses to reduce the intensity of the light.

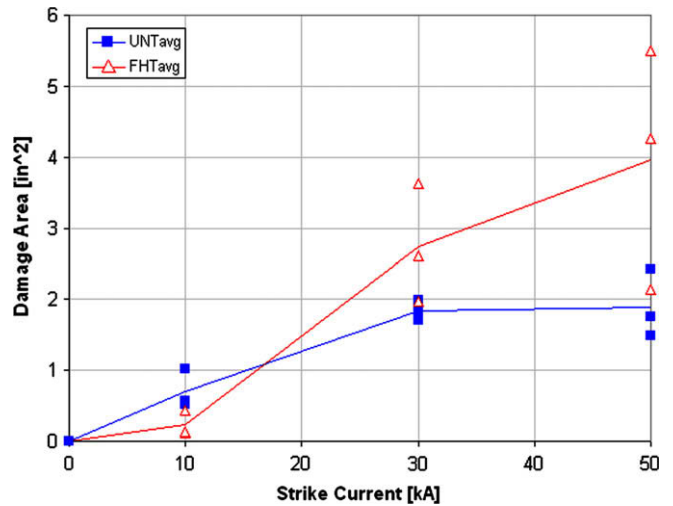
Fig. 11. Projected damage area for unnotched and filled-hole specimens.

Trends observed in projected damage area for filled-hole specimens are reported in Fig. 11, together with the unnotched ones. For filled-hole specimens, the damage area is very small for the 10 kA strikes, but there is a clear inversion in the trends observed for the 30 and 50 kA strikes, where it rapidly grows to larger values than the unnotched specimens. While initially the damage area appears to grow at a slow rate, between 10 and 30 kA there is a sharp increase, and even between 30 and 50 kA strikes the area appears to grow substantially, albeit at a lower rate. The steel fastener appears to act as an electrical damage sink for the low current levels, whereby it absorbs the majority of the damage, but at the higher current levels it appears to become an amplifier, thus distributing the load throughout the entire laminate rather than containing it on the outer plies.

It should be noted that the variation in damage area measurements for the filled-hole specimens is much greater than for the unnotched ones, and in particular it becomes nearly unacceptable at 50 kA. It is suggested that fastener fit may have a fundamental role in introducing the electrical load in the surrounding laminate, and hence the quality of the fit may be responsible for the great variation observed. Future work will have to focus on the fundamental role of the metallic fastener in the formation of damage.

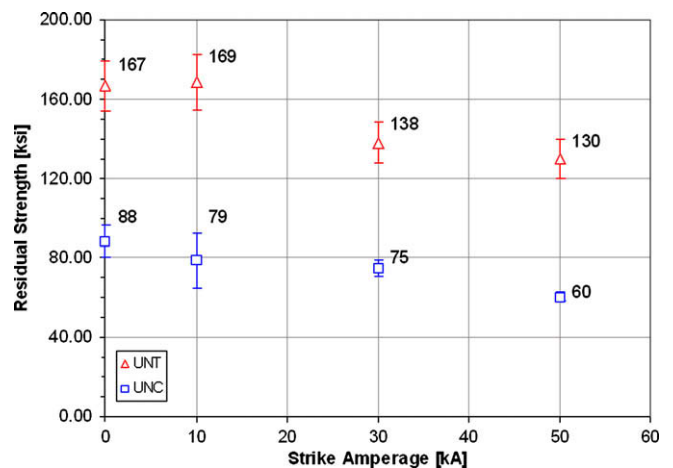
Residual strengths for UNT and UNC specimens, families A–D and E–H, respectively, are shown in Fig. 16. It is interesting to observe that at the maximum energy level, 50 kA, the reduction in tensile strength is approximately 20%, while in compression it is slightly over 30%. Unnotched residual strength for both tension and compression decreases in a relatively linear fashion with current intensity. These values are the averages of three test specimens per family. Residual modulus measurements are plotted in Fig. 17, and shows that, both for UNT and UNC, modulus appears to remain nearly constant in the entire range of currents. Even at 50 kA the decrease is minimal, but large variation in the data is visible. It is counterintuitive that the elastic response of the damaged specimens is not affected to a greater extent by the presence of damage, particularly in compression.

Fig. 16. Residual tension and compression strength plot as a function of current intensity for unnotched specimens.

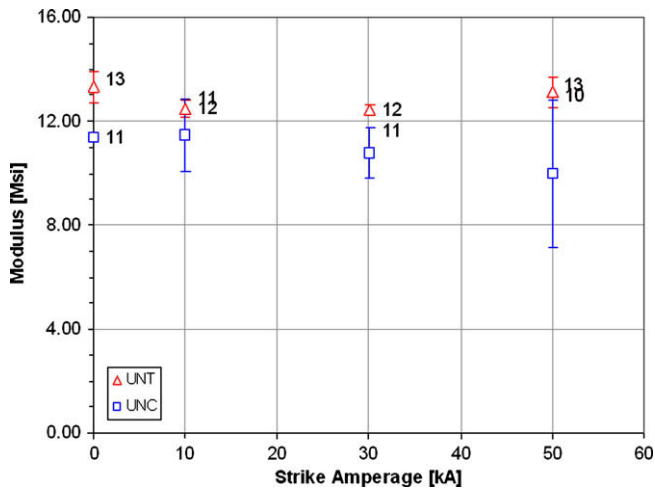
Fig. 17. Residual tension and compression modulus plot as a function of current intensity for unnotched specimens.

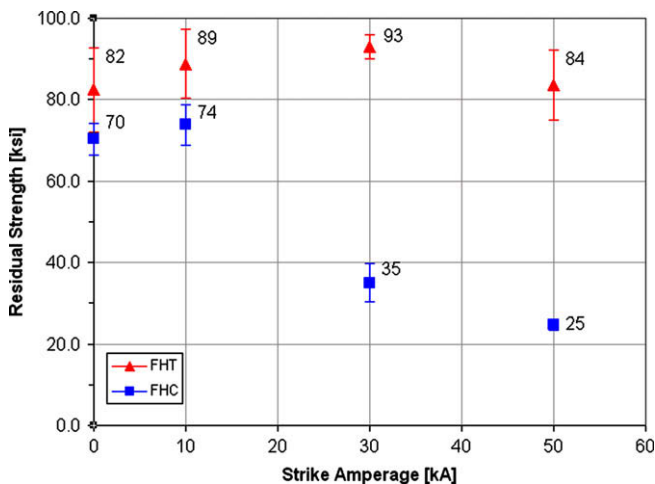
FHT and FHC results are reported in Fig. 18. Average strength values for FHT appear to increase with increasing damage state, up to 13% for 30 kA, then decrease back to the pristine value for the 50 kA specimens. Initially these results may seem surprising, but previous results published by Boeing [6] appear to confirm the observation of increasing FHT strength with lightning strike damage. In [6], FHT specimens having the same geometry as those of this study are shown a clear trend of increasing apparent strength after strike, Fig. 19. Noticeable scatter is present in their data, as well as in the current investigation. It should be noted that the specimens used in [6] are stitched AS4/3501-6 resin film infused deriving from the NASA advanced composites technology (ACT) program, and are substantially thicker than the ones used in this investigation. Nonetheless, for both specimen types it is thought that the lightning strike damage surrounding the fastener acts as to relieve the stress concentration around the hole in a fashion not too different from that of the damage zone evolution reported by several authors during testing of open- or filled-hole specimens [16,17].

For the FHC specimens, also reported in Fig. 18, the results also appear to slightly increase for the 10 kA strike, then rapidly drop by as much as 65% for 50 kA. It appears therefore to be confirmed that the fastener has an extremely significant role in both the damage resistance and damage tolerance response of the CFRP specimens.

Fig. 18. Residual tension and compression strength plot as a function of current intensity for filled-hole specimens.

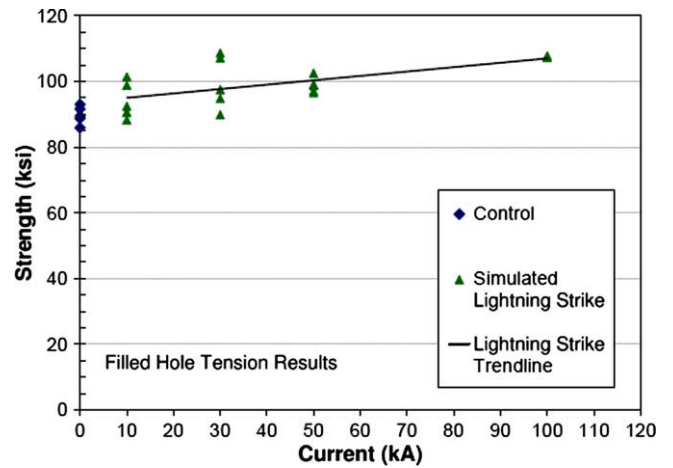
Fig. 19. Increase in residual strength with increasing current for filled-hole tension specimens reported in [6].
