# Damage of Carbon/Epoxy Composite Plates Subjected to Mechanical Impact and Simulated Lightning

Paolo Feraboli\* and Hirohide Kawakami†  
*University of Washington, Seattle, Washington 98195-2400*

**Damage is inflicted on carbon-fiber/epoxy composite plates using both simulated lightning strike and mechanical impact in the effort to understand the relative effect of the two damage mechanisms. A methodology is proposed to characterize the damage resistance and tolerance of unconfigured composite plates subjected to lightning strike in a fashion that is consistent with the extensive work previously done on low-velocity impact. Using current and voltage diagnostics, it is possible to extrapolate the amount of electromechanical energy absorbed by the plate during the strike and compare it to that absorbed during a mechanical impact. Damage resistance is characterized by means of ultrasonic C-scans and microscopy, whereas residual strength is measured by means of compression after impact testing. Results show that the energy dissipated in a specimen during the lightning strike is much greater than the strain energy introduced by mechanical impact, and hence a comparison based on ener

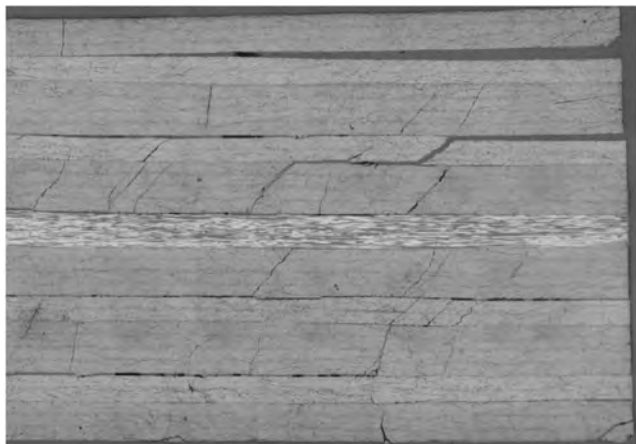
**Fig. 15** Detail of the specimen impacted at 15 ft · lb (20.34 J) perpendicular to the 0 deg fibers and underneath the point of impact.

next stack of plies (see Fig. 13). This is the typical aspect of a delamination tree and is characterized by few thin and short delaminations for the majority of the polished specimen. The area right underneath the impact point appears mostly pristine. Below the midplane of the laminate, there appears to be extensive cracking perpendicular to the plies, rather than at 45 deg, which suggest to be tensile matrix cracks in the 90 deg direction. At 15 ft · lb (20.34 J), the overall aspect of the cross section is the same (see Fig. 14), but the delaminations are larger and more diffused with complete separation of some of the ply stacks from the neighboring ones (see Fig. 15). There appears to be minor fiber breakage on the backface. For 25 ft · lb (33.89 J), the amount of damage in the upper portion of the laminate is very extensive with fiber breakage more diffused at the backface (see Figs. 16 and 17).

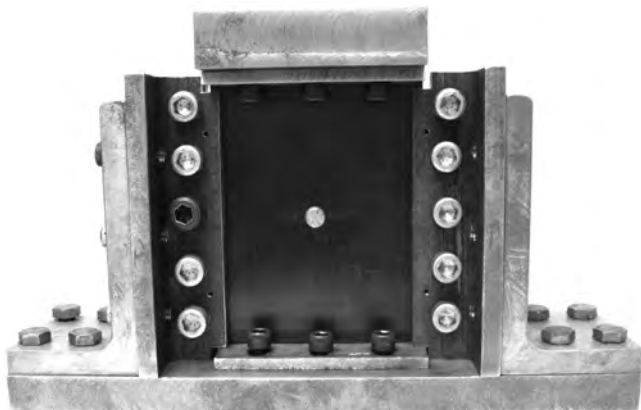
Fig. 24 CAI test fixture with filled-hole specimen following lightning strike damage.

After inflicting damage onto the specimens, these are tested to failure using the Boeing-derived CAI fixture [17] to quantify the loss in mechanical performance because of the presence of damage (see

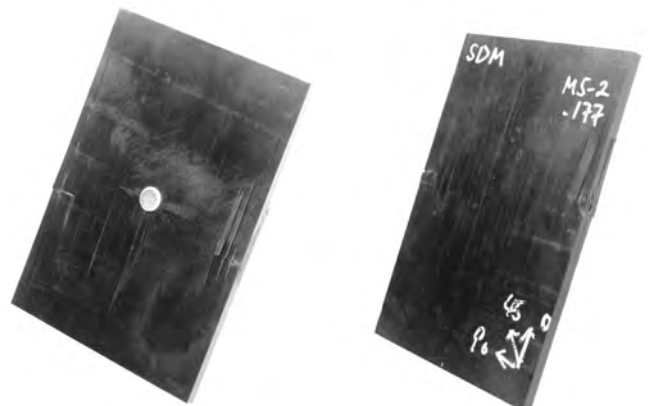
Fig. 25 70 kA lightning strike specimen (left) and 25 ft · lb (33.89 J) impact specimen (right) following residual strength CAI testing.

Fig. 24). For both pristine and filled-hole specimens, strength is calculated based on the gross section area, consistently with aerospace practice [12]. All specimens reported failed in the net section by an acceptable accepted compression failure mode as indicated by ASTM [17] (see Fig. 25).
