Lightning strike damage resistance and tolerance of scarf-repaired mesh-protected carbon fiber composites

Hirohide Kawakami¹, Paolo Feraboli^{*}

Department of Aeronautics & Astronautics, University of Washington, United States

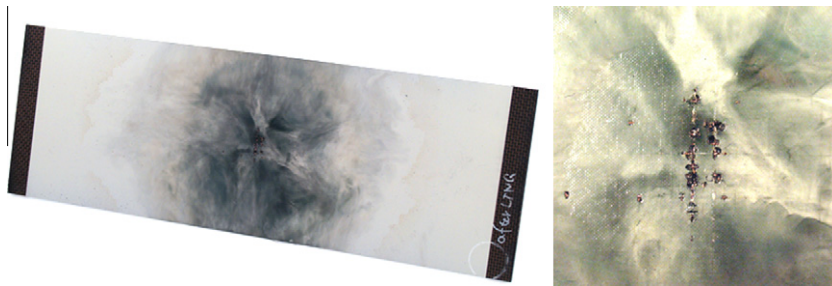
Fig. 14. Visual and close-up view of GR80. (For interpretation of the references to color in this figure legend, the reader is referred to the web version of this article.)

For specimens that have undergone scarf repair, the state of damage was dramatically different depending on the quality of the repair. For specimens with good repair GR80, where the repair mesh overlaps the parent mesh, the results were virtually identical to the unrepaired, protected specimens (M80 and MP80), Fig. 14. Visible damage was small and had the same elongated appearance. For specimens with poor repair PR80, three different possible states of damage could be encountered, Fig. 15A–C. In Type I damage, the lightning attached away from the center of the specimen and inflicted damage on the parent material outside the patch repair, Fig. 15A. In Type II damage, the damage ran along the entire

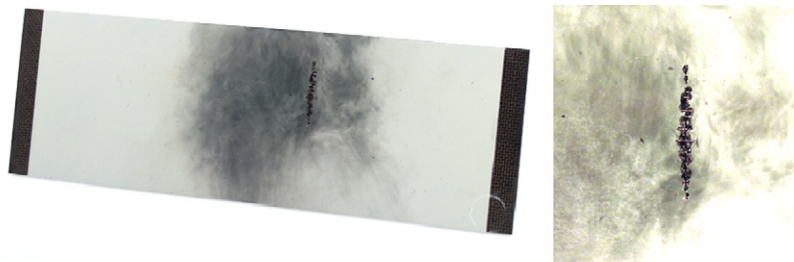
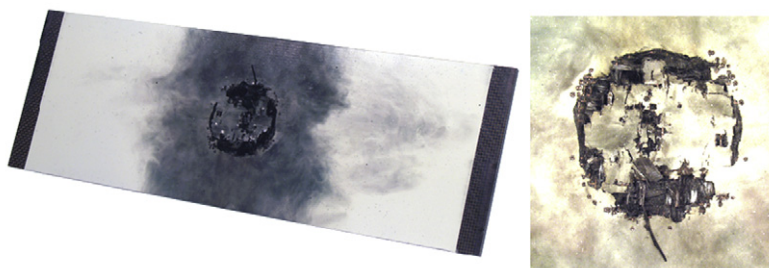
(A) Family PR80, Type I damage

(B) Family PR80, Type II damage

(C) Family PR80, Type III damage

Fig. 15. (A and C) Visual and close-up view of PR80 Type I damage (A), Type II damage (B), Type III damage (C). (For interpretation of the references to color in this figure legend, the reader is referred to the web version of this article.)

circumference of the patch, with clearly visible fiber and matrix burning and vaporization, giving the appearance of a circular annulus of damaged material, Fig. 15B. In Type III damage, the entire patch was detached from the specimens, leaving the scarf area completely empty, with other evidence of burning around the circumference, Fig. 15C. For both Type II and Type III damage, the lightning attachment point was the center of the patch, with secondary leaders attaching to the edge of the repair patch. Statistically speaking, 7 of the 9 specimens tested with poor repair happened to be struck in the center of the patch (Type II and III damage), while only 2 were struck outside the patch (Type I).

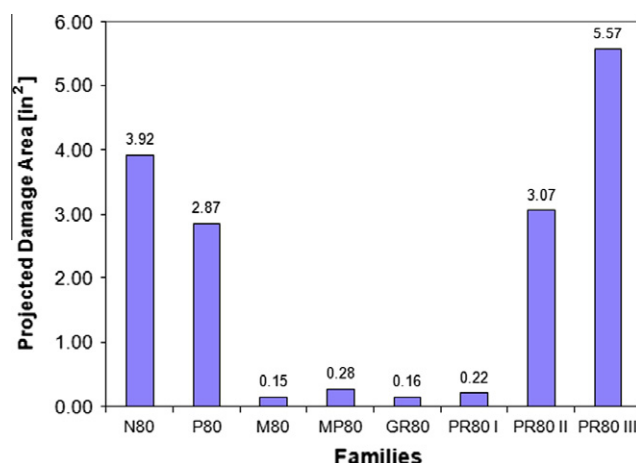
Fig. 17. Plot of the average projected damage area for all families tested. (For interpretation of the references to color in this figure legend, the reader is referred to the web version of this article.)

since the lightning current path was not affected by the presence of the electrical discontinuity at the location of the repair. For Type II and III damage, the state of damage was devastating, regardless of whether the patch flied off from the parent laminate. Ultrasonic scans for the GR80 specimen and three types of PR80 specimens are reported in Fig. 16A–D, while a summary of the results is reported in Table 2. For PR80 Type I damage, the average projected damage area was similar to the families M80, MP80 and GR80; for PR80 Type II damage, the damage area was similar to the families N80 and P80; for PR80 Type III damage, the damage area was even larger than for the unprotected specimens. A plot of the average projected damage area for all families tested is reported in Fig. 17.

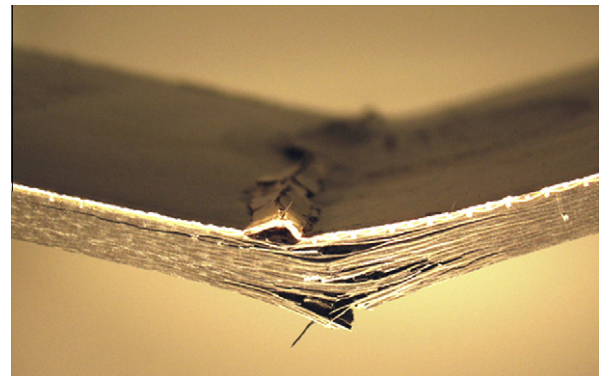
Fig. 23. Typical flexural failure, with tensile fiber breakage on the lower side and compressive kinking of fibers and copper mesh on upper side. (For interpretation of the references to color in this figure legend, the reader is referred to the web version of this article.)

Fig. 23. For specimens with copper mesh, the ductile copper bent extensively out of the plane after locally buckling, and separated from the composite substrate. A summary of the residual strength results for all families is reported in Table 3 and plotted in Fig. 24. For specimens with copper mesh, the flexural strength is calculated using only the carbon fiber laminate thickness, thereby assuming that the contribution of the copper mesh is negligible. It can be seen that the lightning strike damage reduced the flexural strength significantly in the absence of copper mesh protection, and more so for specimens with paint (P80) than without (N80), as compared to the baseline (N0). Results also confirm that the copper mesh had no influence on the pristine strength of the laminate (MP0), as compared to the baseline unprotected strength (N0). Specimens with repair (R0) performed identically to the pristine ones (N0 and MP0), therefore confirming that the repair procedure was of high quality and structural integrity was re-established. Specimens with mesh protection were substantially unaffected in terms of residual strength by the presence of the lightning damage (M80 and MP80) and, similarly, “good” repair specimens (GR80) and “poor” repair specimens displaying Type I damage (PR80 Type I). On the other hand “poor” repair specimens with Type II damage morphology (PR80 Type II) exhibited a similar strength reduction to the unprotected specimens

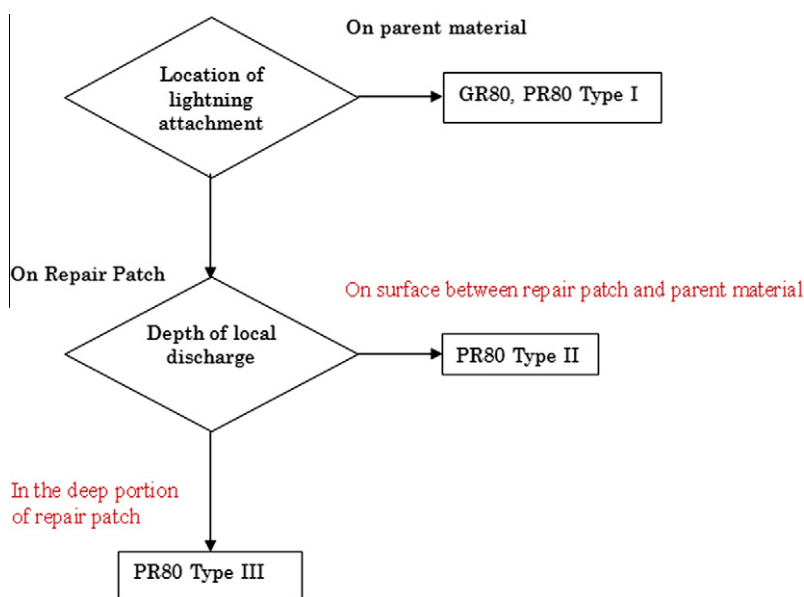
Fig. 26. Types of damage depending on specimen types and location and depth of lightning attachment point. (For interpretation of the references to color in this figure legend, the reader is referred to the web version of this article.)

In this section, the three damage morphologies observed for poor repair specimens (PR80) are discussed qualitatively on the basis of visual inspections, C-scan results and destructive microscopy. The three categories of damage state, and associated residual strength reductions, are related to the location in the plane and through the thickness of the electrical discharge, as summarized in the diagram of Fig. 26. When lightning strikes a “poor” repair specimen, three possible scenarios can manifest. If the location of the strike falls outside of the repair patch (i.e. somewhere on the parent material, Fig. 27), the extent of the visible and internal damage is approximately identical to mesh-protected non-repair specimen (M80 and MP80), as well as a “good” repair specimen (GR80). The majority of the damage is confined to a protective copper mesh layer, while the majority of the carbon fiber remains intact. This is the scenario encountered for PR80 Type I specimens.

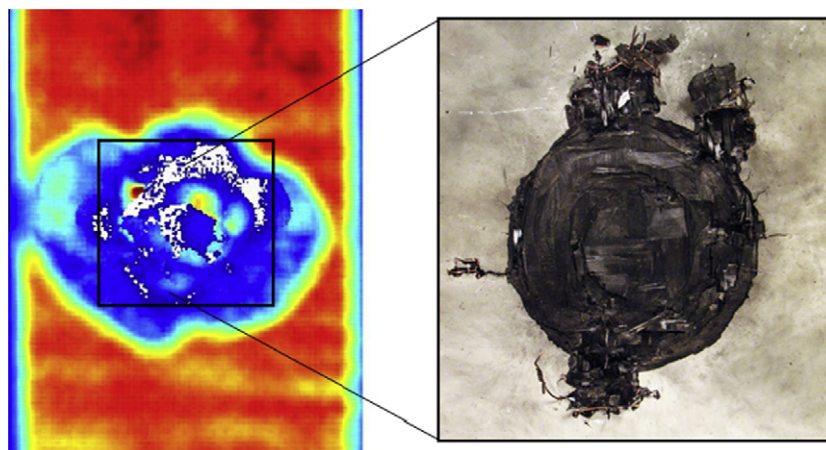
Fig. 31. Details of internal and external damage on PR80 Type III specimen, where the scarf patch is ejected during the lightning strike event and a much broader damage area can be observed below the surface. (For interpretation of the references to color in this figure legend, the reader is referred to the web version of this article.)

P80 and PR80 Type II); and (C) repair patch flies off and damage spreads out over the parent material (family PR80 Type III).
