# HIGH-PERFORMANCE Composites

# AUTOMOTIVE CFRP: Repair or Replace?

As more carbon composites are used for structural car components, how will crash damage be assessed and repairs be made? BY PEGGY MALNATI

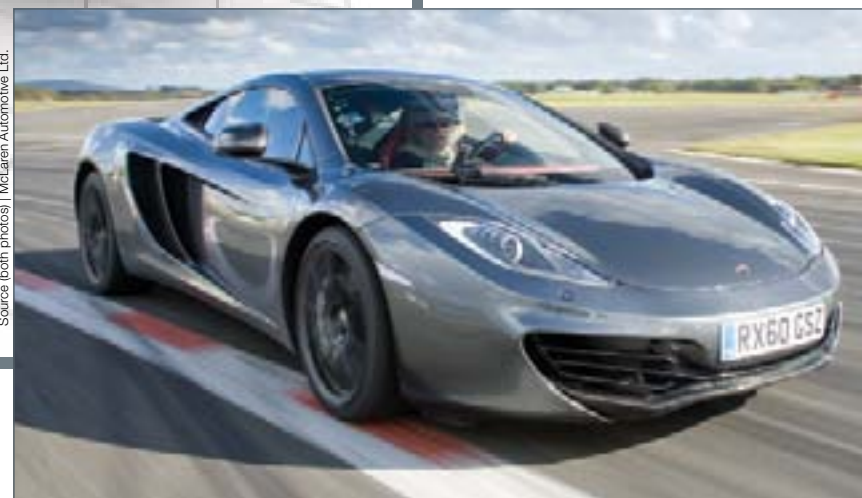
McLaren Automotive Ltd.'s *MP4-12C* supercar features an all-CFRP "MonoCell" monocoque/passenger cell/chassis (center in exploded view). RTM'd in one piece, the 75-kg/165-lb "tub" not only provides the vehicle with rigidity and lightweight strength (dry weight is only 1,301 kg/2,868 lb) but also ensures superior occupant protection, similar to that found on F1 cars, in the event of a crash. The car also features extensive CFRP in sill panels, steering wheel, seats, interior trim panels, rear diffuser (red-orange, in exploded view), front splitter, and exterior turning vanes.

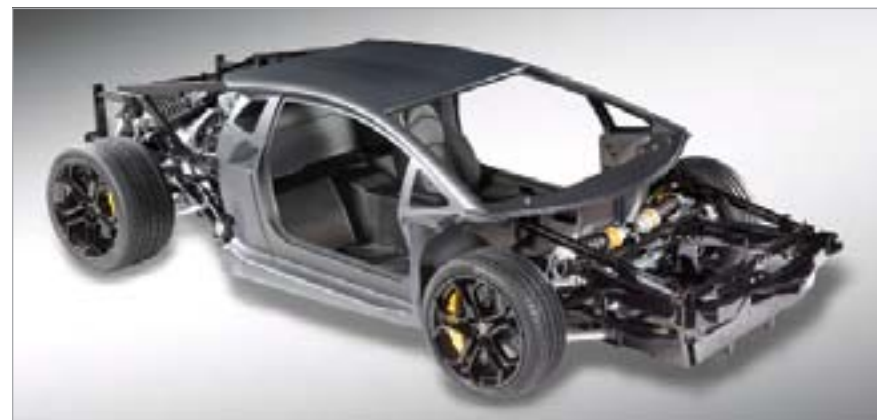
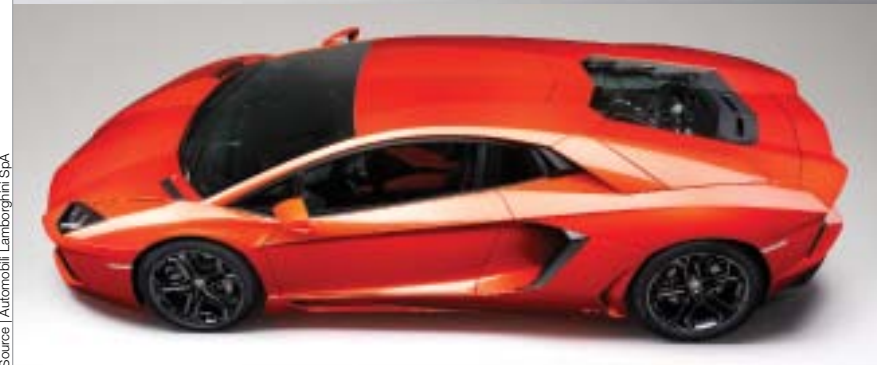
**Composite roll-cage for F1 safety off the track**

Automobili Lamborghini's new *Aventador LP700-4* sports a one-piece, all-CFRP monocoque coupled, front and rear, to rigid aluminum subframes (top photo). The unibody design forms a full roll cage for Formula 1-type occupant protection. Recognizing early on that such extensive use of carbon composites would render the vehicle challenging to repair in the field, Lamborghini — in collaboration with Boeing and University of Washington's Automobili Lamborghini Advanced Composite Structures Laboratory — developed a strategy for assessing damage sustained by the car's CFRP elements and then providing field repairs.

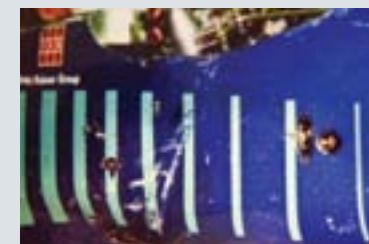
**Step 1**

Damage (white scars/scuffs) sustained by Formula 1 car when wheel was pushed into the CFRP chassis during a race.

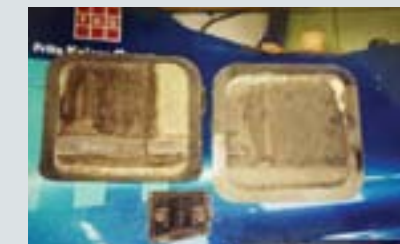
**Step 2**

Outer skin and core removed from damaged area. Outer skin is chamfered with a 30-mm/1.2-inch wide beveled edge prior to being joined to patch.

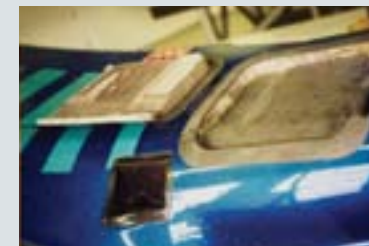
**Step 3**

Repair patch is a precured outer skin with honeycomb that will be bonded in with a paste adhesive.

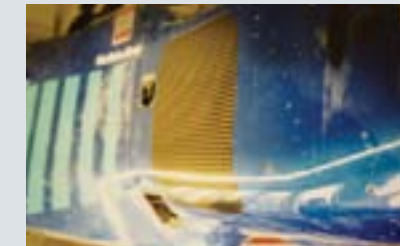
**Step 4**

Damaged area now fixed with patch, which fits flush to skin of racecar.

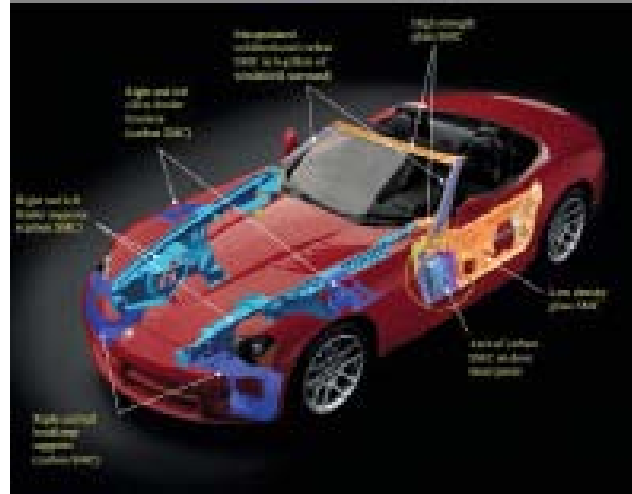
### Fender supports: Bonded but removable

Repairing carbon composite elements attached to the body-in-white of street cars isn't new. On earlier versions of the Dodge *Viper* supercar, carbon fiber-reinforced SMC fender supports were joined to the car's steel space frame yet could be removed and then serviced or replaced. The three-piece assembly was adhesively bonded and riveted together, then bonded to the vehicle's steel spaceframe. Chrysler dealership mechanics would heat the part, remove it, clean the area, and bond a new fender support in place.

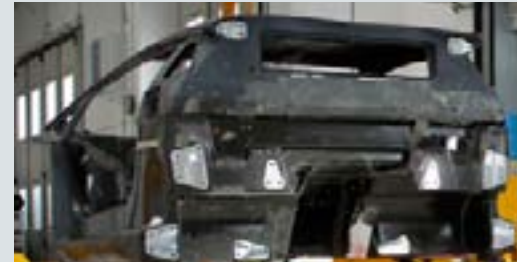
### Step 1

The body shop where the damaged vehicle is taken strips the car down so that bare carbon components will be exposed and ready for inspection and repair by Lamborghini's "flying doctor" upon arrival.
