Composites: Part A

Defect and damage analysis of advanced discontinuous carbon/epoxy composite materials

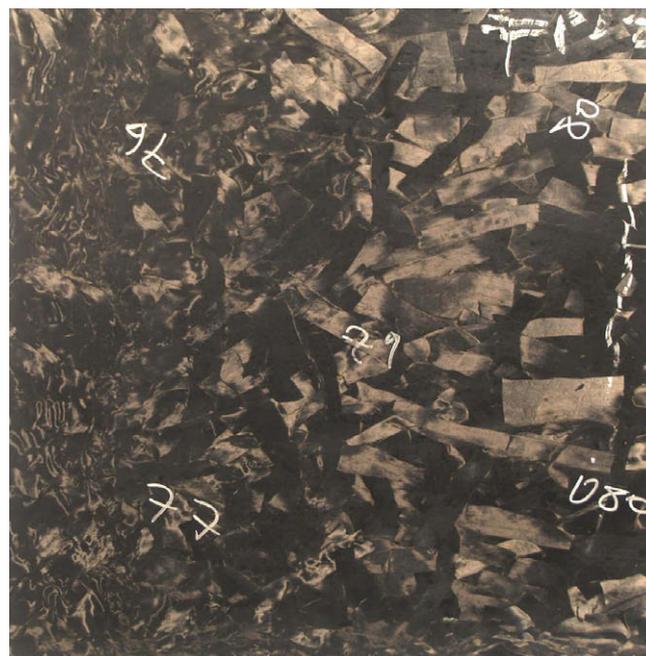
Fig. 1. Molded and trimmed panel.

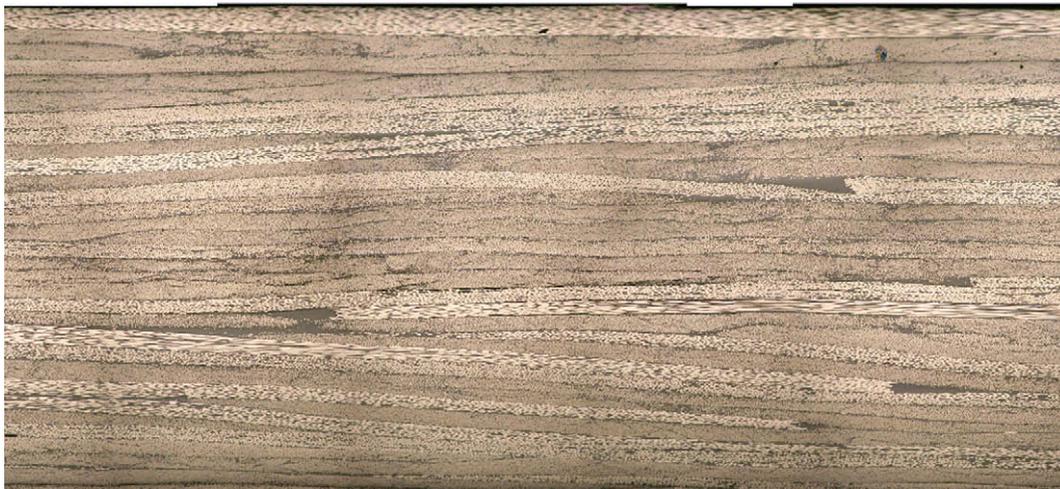
Fig. 2. Typical cross section of pristine (high quality) material, showing the randomly oriented chips alternating through the thickness.

All discontinuous carbon/epoxy specimens are manufactured in the laboratory starting from unidirectional tape prepreg. The system is a 350 °F cure (177 °C), designated for vacuum bag, autoclave cure, and has a resin content of 45%. During molding, 2–3% by volume or resin is lost in flash and through vent holes, which are used to evacuate air, so that the final fiber volume content is around 57–78%. The chip dimensions are 2.0 in. long \times 0.33 in. wide (50.8 mm \times 8.4 mm). Detailed discussion of the compression molding manufacturing process for the material is reported in [6]. After extraction from the mold, the panel is trimmed 1.0 in. (25.4 mm) on all sides to remove the regions of high flow toward the mold edges, where it is more likely that chip alignment and distortion may occur, Fig. 1. Although this is a low-flow process, unlike typical SMC molding where the charge covers only a small fraction of the mold, some degree of resin flow still takes place during the molding process. This is not sufficient to create a noticeable alignment of the fibers along any preferred direction, but inevitably lead to the formation of small resin-rich areas. Average panel thickness is 0.165 in. (4.2 mm), and corresponds to a nominal number of 32 chips through the thickness, each with a cured thickness of 0.005 in. (0.13 mm), Fig. 2.

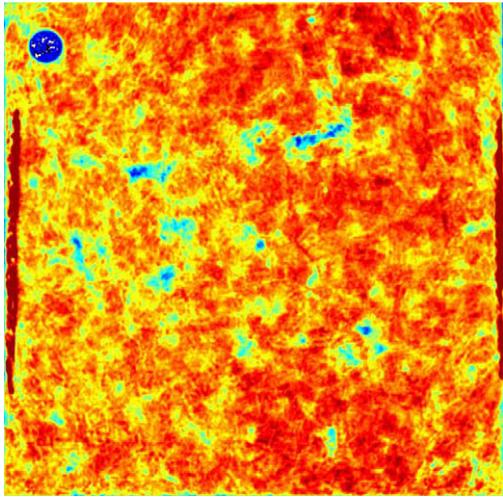
Fig. 3. C-scan pulse-echo ultrasonic image of a molded panel using a 5 MHz sensor.

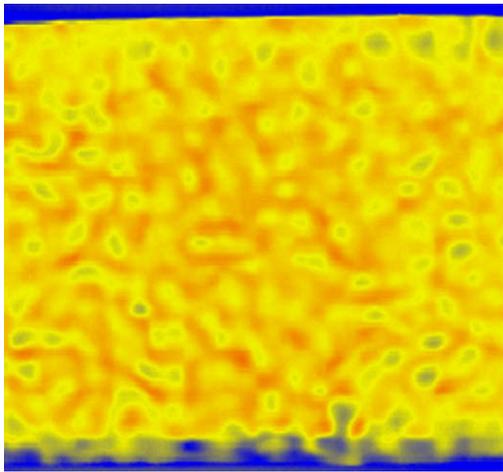
Fig. 4. Pulsed thermography analysis of molded panel in Fig. 3, courtesy of Thermal Wave Imaging Inc.

Pulsed thermography is used to evaluate its suitability to better detect the presence of damage. Thermal Wave Imaging, Inc. is subcontracted to perform non-destructive inspection of a selected number of panels using their Echotherm Infrared Flash Thermography system. The image of Fig. 4 shows that for this material system thermography is not a suitable tool to detect the presence of small manufacturing defects, or hot-spots. Using the 5 MHz frequency as the benchmark for ultrasonic inspection, sensor frequencies of 2.25 and 10 MHz are evaluated to assess their ability to isolate the presence of hot spots from the-background noise, Fig. 5. It can be seen that at 10 MHz the image shows a greater number of regions of signal attenuation, but the increased sensitivity and detail is hindered

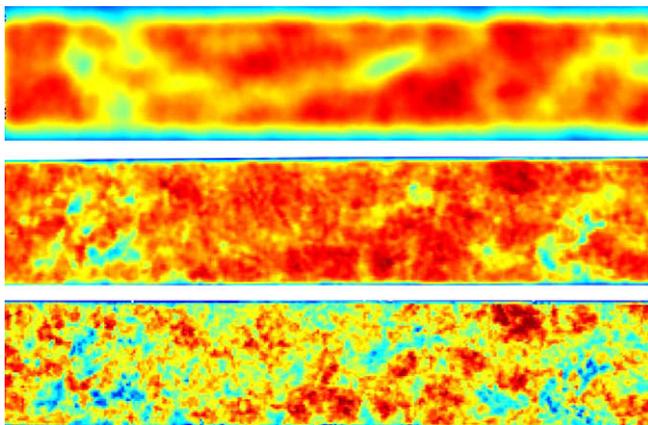
Fig. 5. C-scan pulse-echo ultrasonic image of a specimen using 2.25, 5 and 10 MHz sensors (top to bottom).

by a greater difficulty to discriminate these regions from the background noise. On the other hand, the 2.25 MHz sensor shows a much smoother signal contour, and the areas of signal attenuation are clearly defined. However, the image loses sufficient detail to change the shape and size of some key regions of signal attenuation, and in some cases completely misses them. For these reasons, ultrasonic inspection using the 5 MHz sensor is deemed the most suitable NDE technique, giving the best compromise between sensitivity and noise, and will be used for the rest of this study.

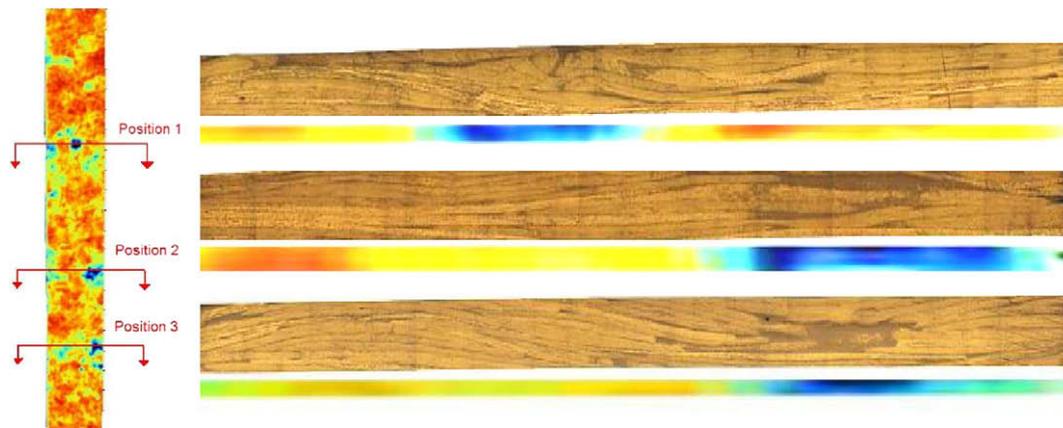
Fig. 6. Micrographic images of three different hot-spot regions in the specimen #2 shown on the left.

Ultrasonic C-scan inspection is used on specimens #1–4 to detect the presence and location of hot spots, but only two specimens are shown in this section, as they are sufficiently representative of the whole set. At the location of the hot spots, the specimens are sectioned to obtain smaller specimens for micrographic inspection. Specimen #2 is shown in Fig. 6, and highlights the presence of three well-defined regions of signal attenuation, indicated in blue. The micrographic images associated with each of the hot spots are shown on the right. At position 1, the hot spot is associated with the presence of a large swirl, which is a region of extensive chip kinking and distortion associated to a region of high flow. As mentioned previously, although these materials are designed to be low-flow, that is the majority of the mold cavity is covered by the charge, in some regions higher flow may occur due to an inconsistency in the charge distribution. Positions 2 and 3, in the same specimen, show large resin pockets, one toward the surface and the other toward the midplane of the laminate. During molding the resin liquefies and fills the interstices left between neighboring chips. While this is a desired attribute, if the mat used in the charge exhibits a particularly large empty space, for example associated with a missing chip, the resin will concentrate in this region and form resin-rich pockets. Specimen #4, Fig. 7, exhibits two hot spots, which both reveal to be associated to the presence of several large voids. These macro-voids are much larger than the typical

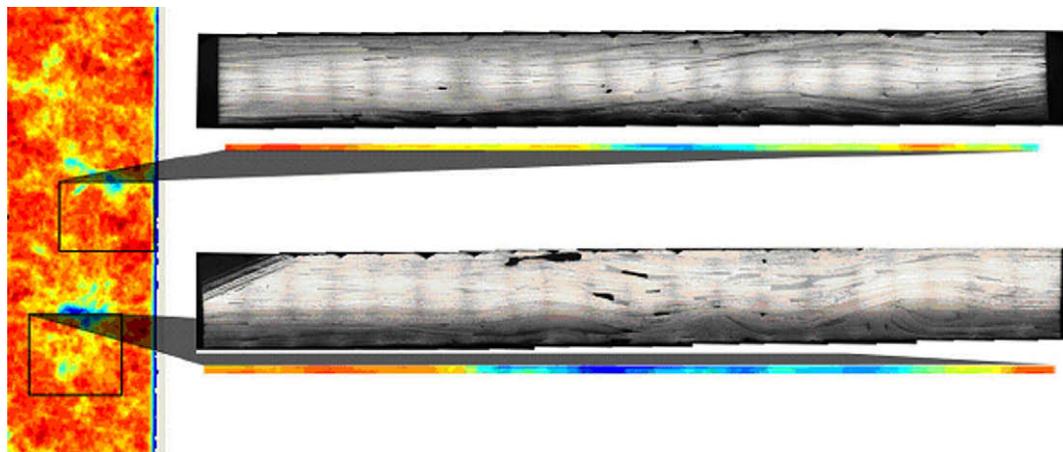
Fig. 7. Micrographic images of two different hot-spot regions in the specimen #4 shown on the left.

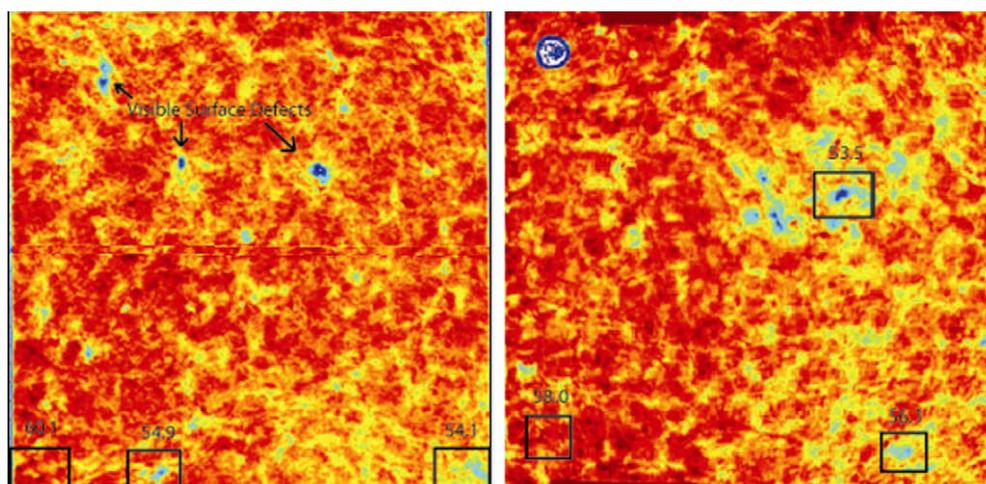
Fig. 8. Acid digestion locations and fiber volume content results for specimens #5 and #6.

Specimens #5 and #6 are used for acid digestion testing. For each panel, three specimens are identified by C-scan as corresponding to a region of pristine signal (red/orange), of partial signal attenuation (green/light blue), and of high signal attenuation (dark blue), Fig. 8. Results show that the pristine regions have high fiber volume content of 59%, regions of modest attenuation have an average of 55.5%, while regions of high attenuation have an average of 53.7%. These results confirm the microscopic analysis observations, which seem to indicate that these hot spots are associated to macro-voids, chip swirls or resin-rich areas, all of which are characterized by low fiber volume content.

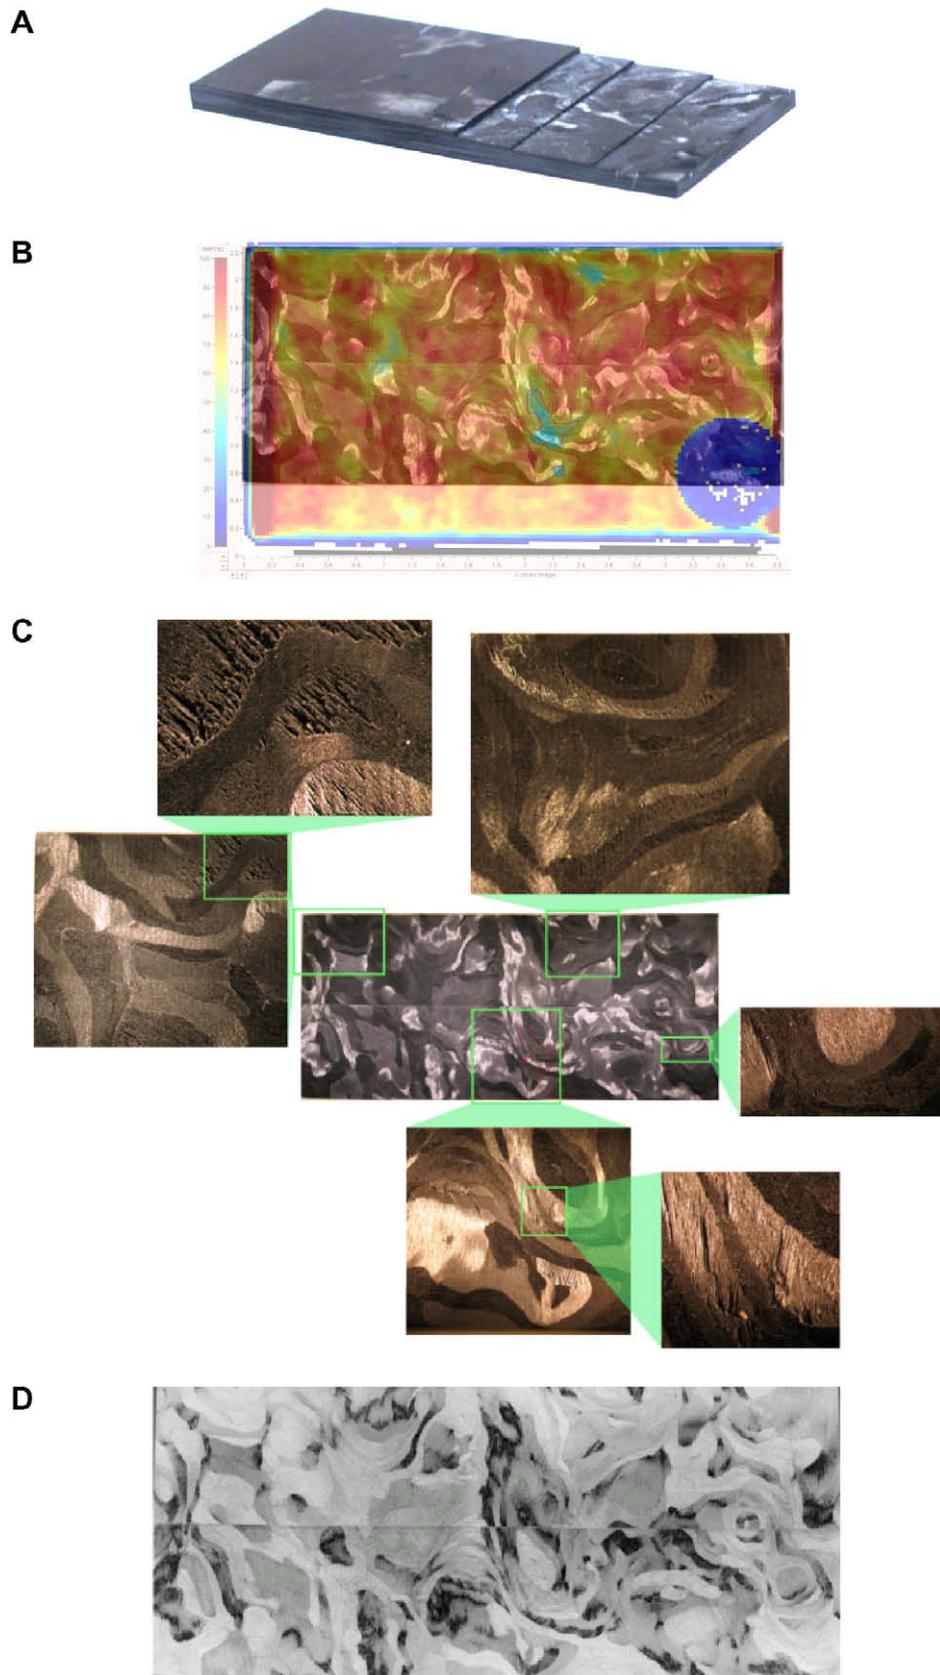
Fig. 9. (A–D) Top view of specimen #7 following surface machining to expose underlying structure and hot spots.

Specimens #7 and #8 are first inspected by C-scan to reveal the presence of hot spots, whose nature location through the thickness is not discernible based on the ultrasonic image alone. They are then placed in a milling machine and subjected to material removal from the top surface down. This process can be performed across the entire surface of the specimen at the same time, or at subsequent steps, Fig. 9A. By superimposing the C-scan image to the machined surface it is possible to focus on the locations of the hot spots, Fig. 9B. After each pass, which is associated with the removal of half a chip thickness, the specimen is inspected under the microscope to verify if the hot spot is visible. From the surface of the specimen in Fig. 9C it is possible to see the presence of macro-voids, visible as either small concave regions or striations, which indicate an elongated shape. The material removal operation is very time-consuming, and does not yield particular insight on the nature of the defects, although it does supply an interesting view of the meso-structure of the material along planes parallel to outer surfaces. Since the chips do not remain perfectly aligned during the molding process, this structure is characterized by highly heterogeneous collection of pseudo-elliptical regions having different chip orientations, Fig. 9D.

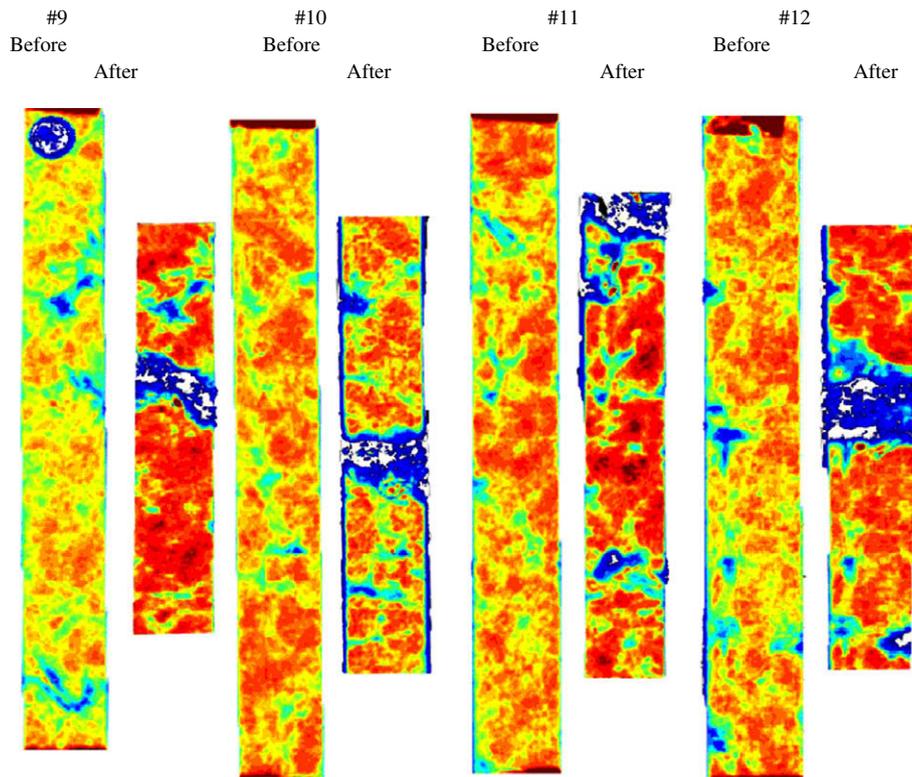
Fig. 10. Ultrasonic images of specimens #9–12 before and after failure.

size, location and intensity, as seen in Fig. 10, and include some that are of high intensity (dark blue) but relatively isolated, and others that are less intense (light blue) but more diffused throughout the specimens. The larger hot spots are then traced out on the surface of the specimens by means of a white marker to monitor if failure occurs at these locations, Fig. 11. The specimens are then loaded to ultimate failure and inspected by ultrasound again, Fig. 10. Three of the four specimens failed in the gage section, while one (specimen 15) failed in proximity of the tabs. Although specimen #9 contains two large hot spots toward the upper and lower parts of the image, failure occurs at a milder hot spot, located toward the center gage of the specimen. Specimen #10 contains 8 mild hot-spot regions dispersed along the specimen, of which one appears to be slightly more intense than others. Failure occurs in the center section in an area that is characterized by relatively mild and spaced hot spots, while the larger hot spot seems unaffected in size and intensity. On the other hand, two of the milder hot spots, one toward the upper part of the specimen, and one toward the lower part, have grown significantly in size and intensity during loading. Specimen #11 fails at the tabs, in proximity of the grips, but a closer look reveals that a relatively dense number of hot spots exist in that region prior to loading. From the post-failure ultrasound, it appears that these hot spots grow and coalesce during loading, leading to failure in that region close to the tabs. Another large hot spot region has grown during loading toward the bottom of the specimen, in a region that was apparently free of hot spots, and at failure its size and intensity is nearly as large as that where failure occurred. Specimen #12 contains 7 hot-spot regions, the majority of which are concentrated on the left side of the specimen in Figs. 10 and 11. The largest one, in the shape of a T, is located toward the center section of the specimen, and is in close proximity to another large hot spot. Failure occurs in that region after those two hot spots grow and coalesce. It should be noted that toward the bottom of the specimen, two other hot spots, located on the opposite sides of the centerline, have grown significantly and started to coalesce.

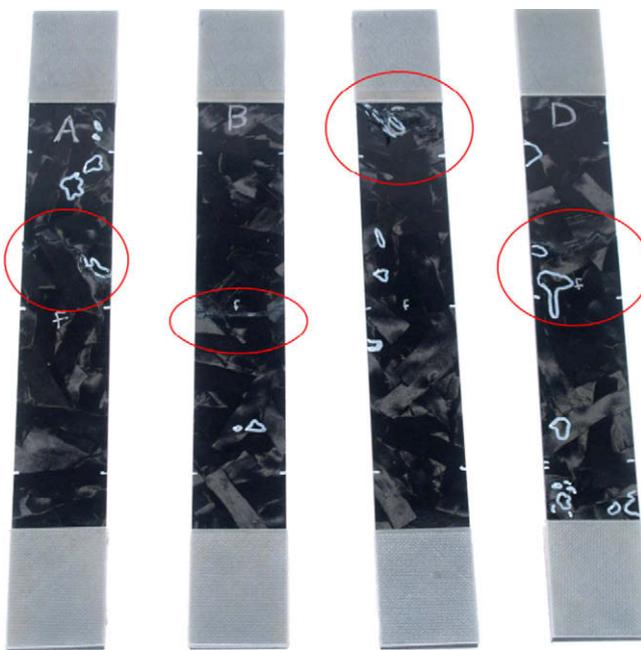
Fig. 11. Specimens #9–12 after failure.

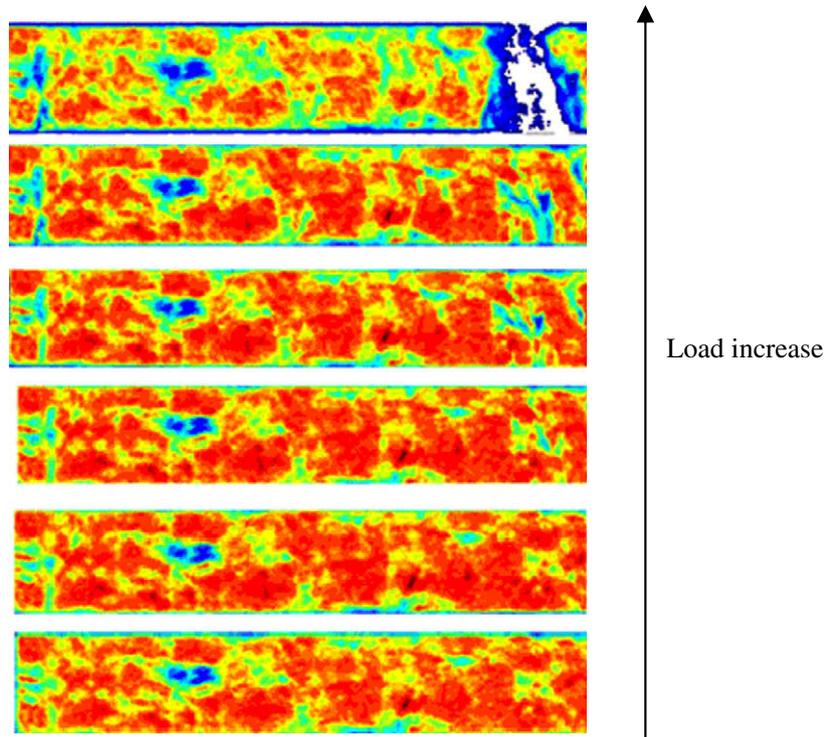
Fig. 12. Specimen #13 undergoing progressive loading and ultrasonic imaging up to ultimate failure.

In order to better capture the evolution of damage and the growth of these hot spots, three tensile specimens are loaded at increments up to catastrophic failure. After each loading increment, the specimen is removed from the test frame and inspected via C-scan. By means of image analysis, the total “damage area” is measured, which is defined as the area of the specimen exceeding a predefined threshold for signal attenuation. Progressive C-scan images are shown for specimens #13–15 in Figs. 12–14. Each figure shows six C-scan images, corresponding to six fractions of ultimate load: 0% (pristine specimen), 60%, 70%, 80%, 90%, and 100% (ultimate load and failure). Specimen #13, Fig. 12, shows the presence of a large, intense hot spot prior to loading. Such hot spot does not grow significantly during loading, and ultimately does not precipitate failure in its proximity. Failure occurs on the right side of the specimen, in an apparently pristine region, where few mild hot-spot regions grow during loading and coalesce. Specimen #14, Fig. 13, shows the presence of several hot spot region of high signal attenuation, with the largest one toward the right of the specimen and in proximity of other two slightly smaller regions. During loading all hot spots grow in size and intensity, and finally failure precipitates when the two hot spots on the right coalesce. For specimen #15, Fig. 14, only four C-scan images are shown since it fails prematurely at 90% of the average ultimate strength of the material. The specimen exhibits a small but intense hot spot in its right side, and two areas of diffused but low-intensity signal attenuation, in the center and to the left of the specimen. Upon loading, the left-most region grows at a much faster rate than the other hot-spot regions, including the high intensity one on the right, and eventually leads to failure. For all specimens the growth is sudden, and at 60% and 70% of ultimate load the change in damage area is virtually undetectable. For the three specimens tested, Fig. 15 shows that at 60% of ultimate load there is virtually no change in the total area of signal attenuation, while at 70% the area is between 10% and 20% larger than the pristine value. Only at 80% of ultimate load the growth becomes evident, at approximately 50% more than the pristine value, and increases more rapidly at higher load values, reaching 150% at 90% of loading.

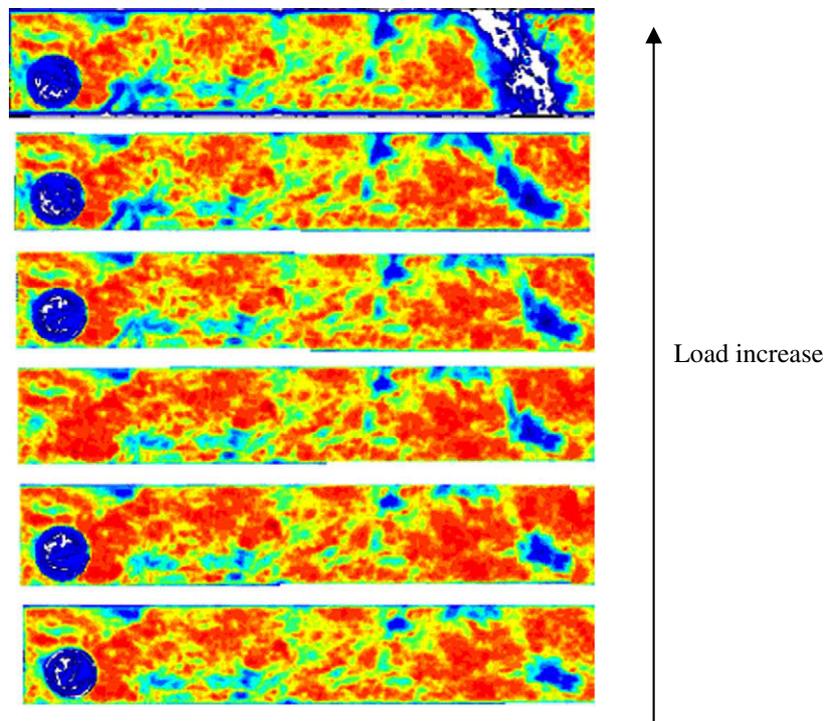
Fig. 13. Specimen #14 undergoing progressive loading and ultrasonic imaging up to ultimate failure.

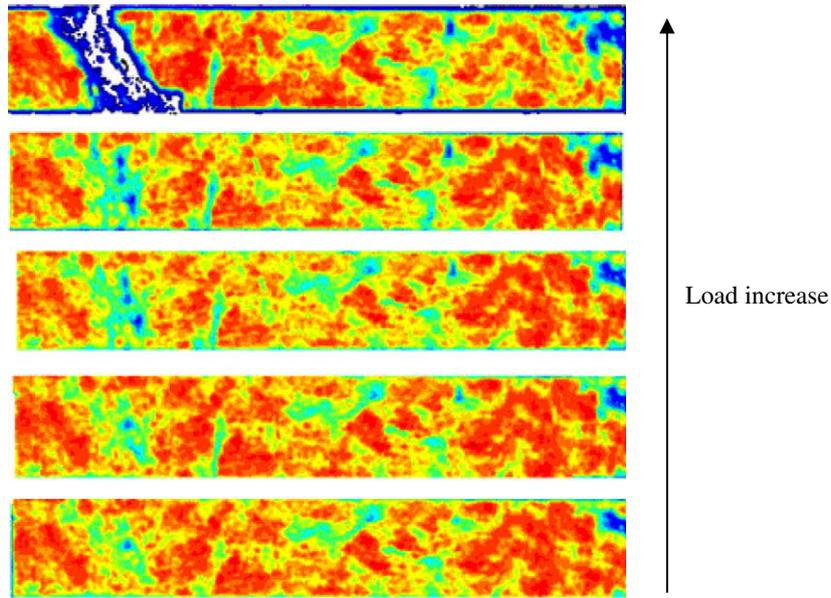
Fig. 14. Specimen #15 undergoing progressive loading and ultrasonic imaging up to ultimate failure.

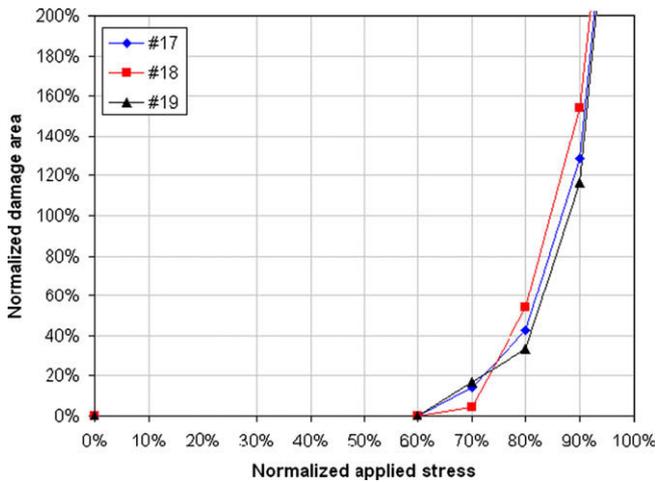
Fig. 15. Normalized damage area vs. normalized applied stress for the three specimens of Figs. 12–14.

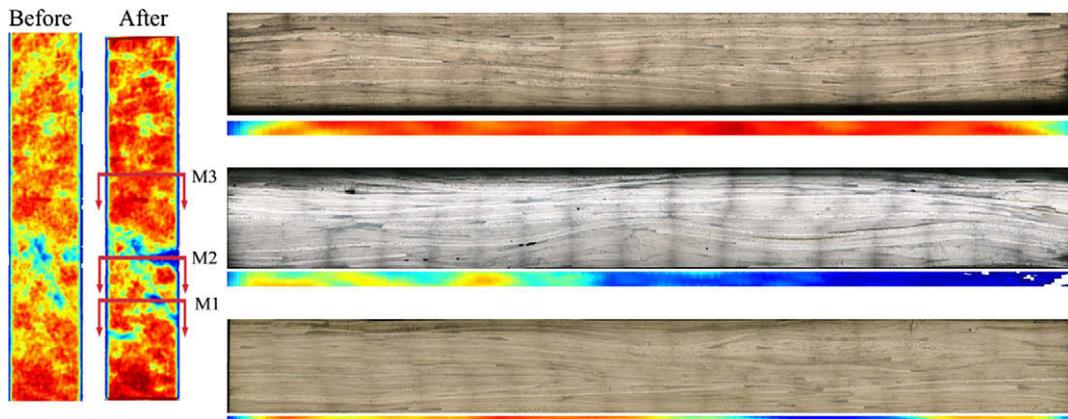
Fig. 16. Specimen #16, inspected by ultrasound before and after loading to 70% of ultimate strength, is then sectioned in three different locations M1–M3.

Specimens #16 and #17 are inspected by ultrasound prior to being loaded to 70% and 80% of ultimate load respectively. They are then inspected by ultrasound again to verify the growth of the hot spots and initiation of damage, and are then sectioned for microscopic analysis to understand the damage mechanisms. Fig. 16 shows this process for specimen #16, from which three dif-

ferent regions are sectioned. These regions, which are designated M1–M3 and showed top to bottom in Fig. 16, include a region of apparent pristine conditions and no signal attenuation (M3), a re-

gion of intense signal attenuation (M2), and an intermediate attenuation region (M1). Section M2 shows a range of multiple defects that appear to concentrate in the same region. These include sev-

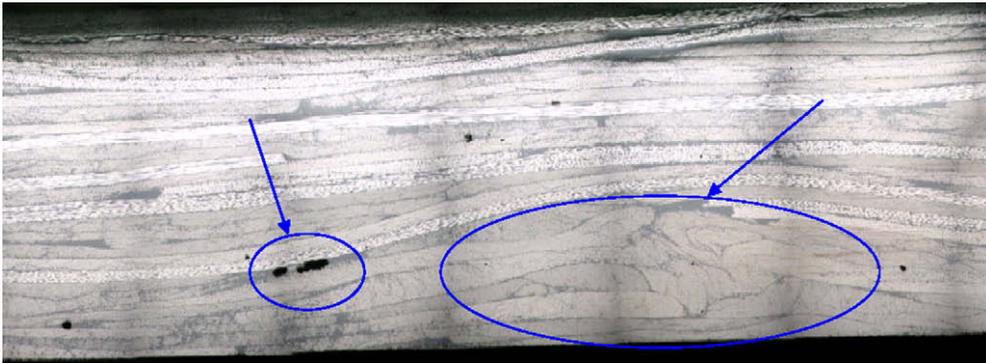
Fig. 17. Detail of section M2, center.

eral macro-voids of varying sizes concentrated on the left side of the cross section, and a large swirl, or region of high flow and fiber kinking in the center of the cross section, Fig. 17. These are present before loading and do not show signs of growth. On the right side of the specimen, Fig. 18, several inter- and intra-chip cracks can be observed through the thickness, as well as multiple large adjacent delaminations, which appear to generate in resin-rich regions in the proximity of chip terminations. Both transverse cracks and del-

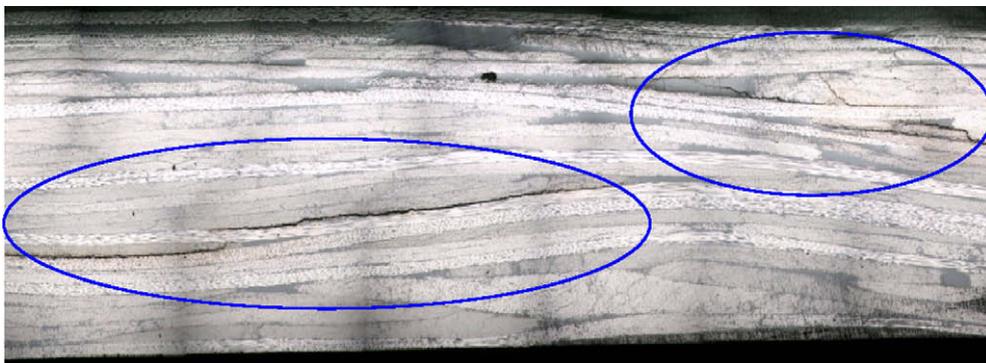
Fig. 18. Detail of section M2, far right.

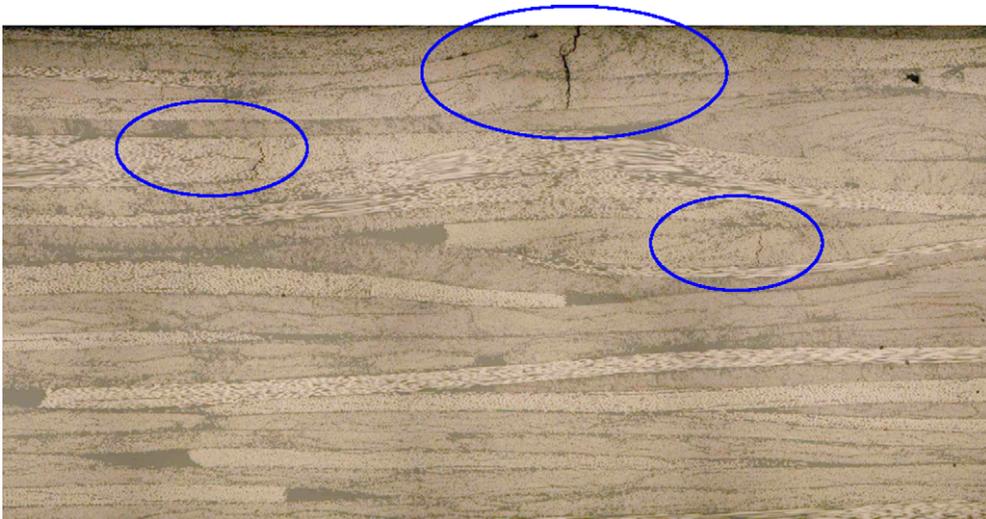
Fig. 19. Detail of section M1, far right.

aminations are the result of the applied load and are responsible for the increase in total “damage” area, or area of signal attenuation as measured by C-scan. Section M1, Fig. 19, of mild signal attenuation exhibits the presence of several intra-chip cracks directed perpendicular to the cross section. These cracks are typical of the early stages of damage initiation and growth, and form in a region without obvious manufacturing flaws or apparent hot spots. Section M3, Fig. 20, which belongs to a bright red region of no signal attenuation, shows a pristine micro-structure as the one reported in Fig. 2. Similar observations from specimen #17 suggest that the relationship between large manufacturing defects, such as voids and swirls, and damage initiation and propagation appears to be all but obvious. Damage does not emanate and grow from the pre-existing defects, although it forms in their proximity. It is possible that the presence of defects may be responsible for locally lower mechanical properties, such as Young’s modulus whose point-to-point variation is documented in [8], and in turn may create high strain gradients in their proximity. These gradients could then affect the local load redistribution and precipitate failure in the pristine material in proximity of these defects. In any case, the presence of hot spots, which are confirmed to be manufacturing defects of varying nature, does not consistently precipitate failure in their proximity.

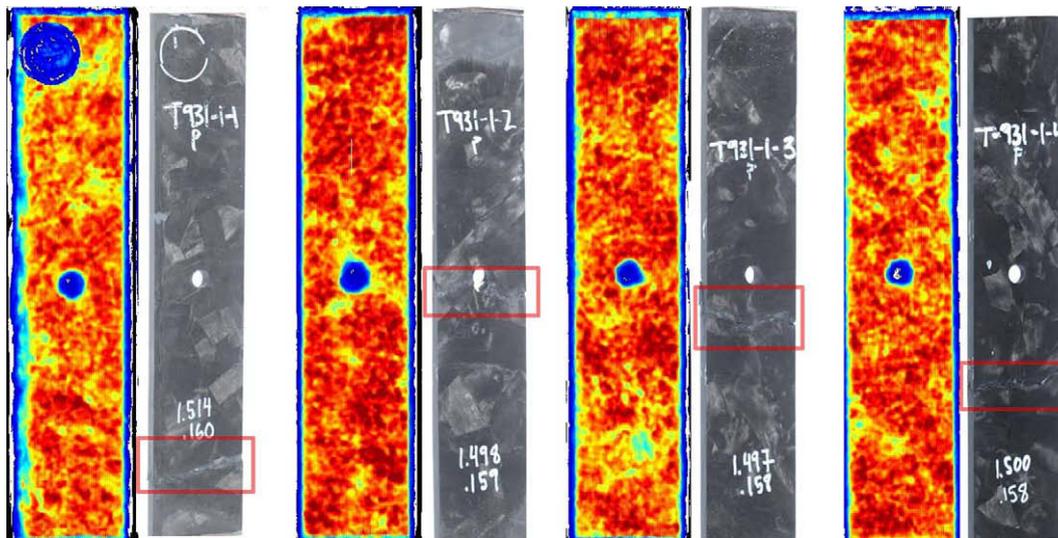
Fig. 20. Specimens #18–21, containing no evident hot spots, are loaded to failure in the presence of an open hole, and in 75% of cases lead to failure away from the hole.

It was previously reported by the authors in [7] that this material form is particularly notch-insensitive, and exhibits an open-hole tensile strength that is unchanged with respect to the unnotched strength. Furthermore, for 0.25-in. (6.35 mm) circular hole, it was reported that at least 50% of the specimens fail away from the open hole, in the gross section. It is thought that such behavior is due to the presence of defects, or hot spots, that create material stress concentrations more dominant than the geometric one. To validate this theory, a series of notched tensile tests are performed on specimens #18–21. Four specimens are selected carefully to ensure that no significant hot spots are present, as shown in the C-scan images of Fig. 20, which are characterized by a uniform red

(high signal) projected area. The specimens are then loaded to failure, but three of the four specimens fail away from the hole, in the gross section area. From the ultrasonic images it is not clear why failure precipitates at a specific point along the specimen, since there are no obvious regions of signal attenuation.

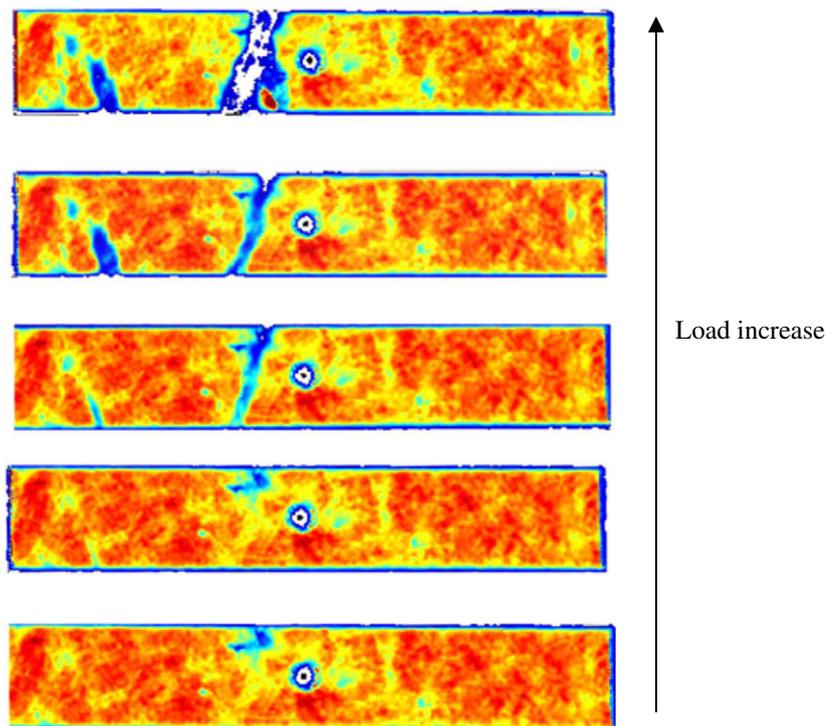
Fig. 21. Specimen #22 with an open hole undergoing progressive loading and ultrasonic imaging up to ultimate failure.

moved and inspected via ultrasound to monitor the growth of damage. As in previous tests for unnotched specimens, five C-scan images are shown for each specimen, corresponding to 0% (unloaded), 50%, 70% 90% and 100% (ultimate failure) increments. Specimen #22, Fig. 21, contains a relatively large hot spot in the proximity of the open-hole. Upon loading, the hot spot grows across the specimen width in a direction away from the hole, and eventually leads to failure in the gross section, although close to the hole. During loading, two large hot spots form on the left side of the specimen, and at failure they have grown to the point that they almost coalesce. Specimen #23, Fig. 22, contains a mildly homogeneous signal, with no clearly defined hot spot. Upon loading, four/five mild hot spots begin to form at different locations along the specimen, and eventually two of them on opposite sides of the specimen width coalesce and precipitate failure. Specimen #24, Fig. 23, exhibits a high-intensity hot spot and a wide region of diffused mild-intensity hot spots to the left of the specimen. During loading these hot spots grow, and in particular the smaller but more intense one coalesces with a neighboring one and leads to failure.

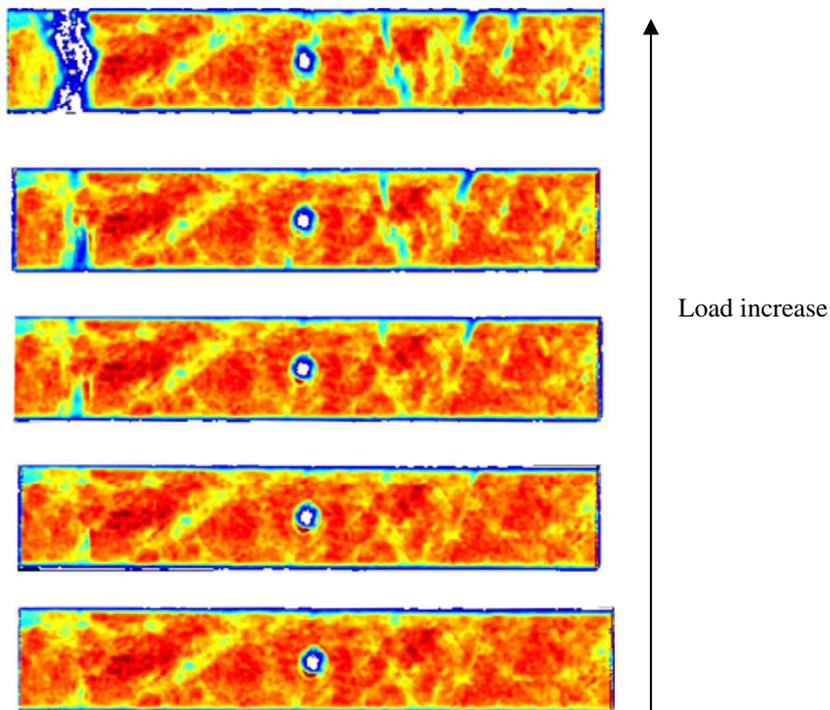
Fig. 22. Specimen #23 with an open hole undergoing progressive loading and ultrasonic imaging up to ultimate failure.

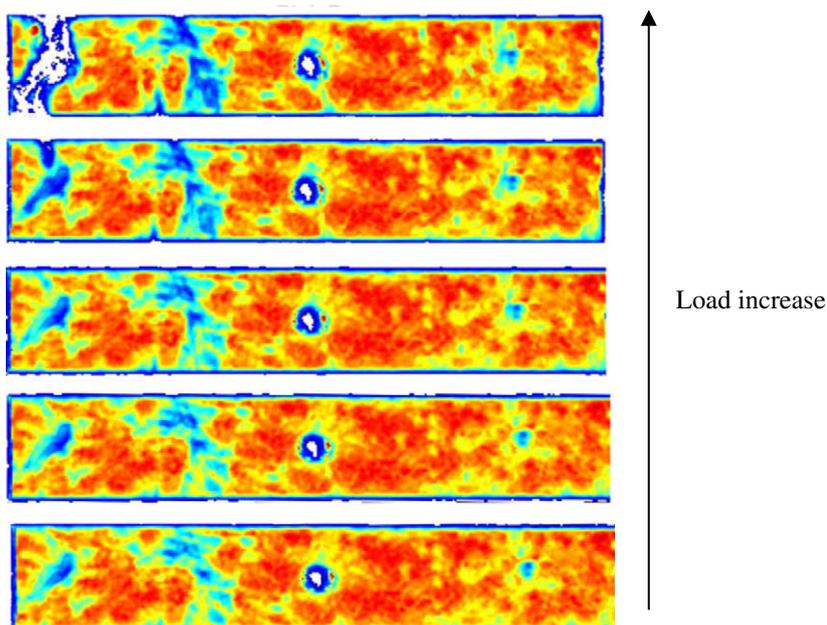
Fig. 23. Specimen #24 with an open hole undergoing progressive loading and ultrasonic imaging up to ultimate failure.
